Another Look at the Collapse of Skyline Plaza at Bailey's Crossroads, Virginia

Jeffrey Schellhammer¹; Norbert J. Delatte, F.ASCE²; and Paul A. Bosela, F.ASCE³

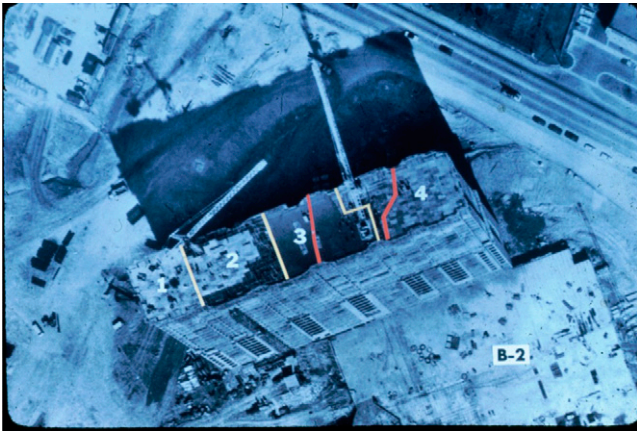
Fig. 1. Aerial photograph of the structure shortly before the collapse (courtesy of NIST)

The collapse killed 14 workers and injured 34 (Carino et al. 1983, p. 35). The area that collapsed is designated as area 3 in Fig. 1. This area also contained a crane; as a result, there was a question as to whether the crane fell and initiated the collapse, or if it just came down with the rest of the building. Once the section of the apartment building collapsed, the failure propagated horizontally through the attached parking garage. Of the workers killed, 10 were in the tower and four in the garage (Leyendecker and Fattal 1977, p. 2).

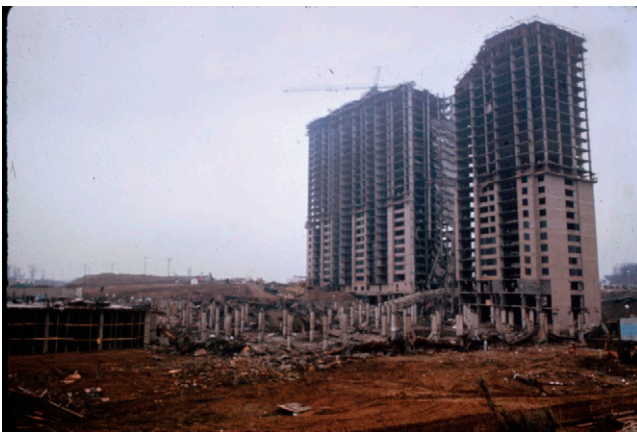
Fig. 3. Another view of the collapsed structure (courtesy of NIST)

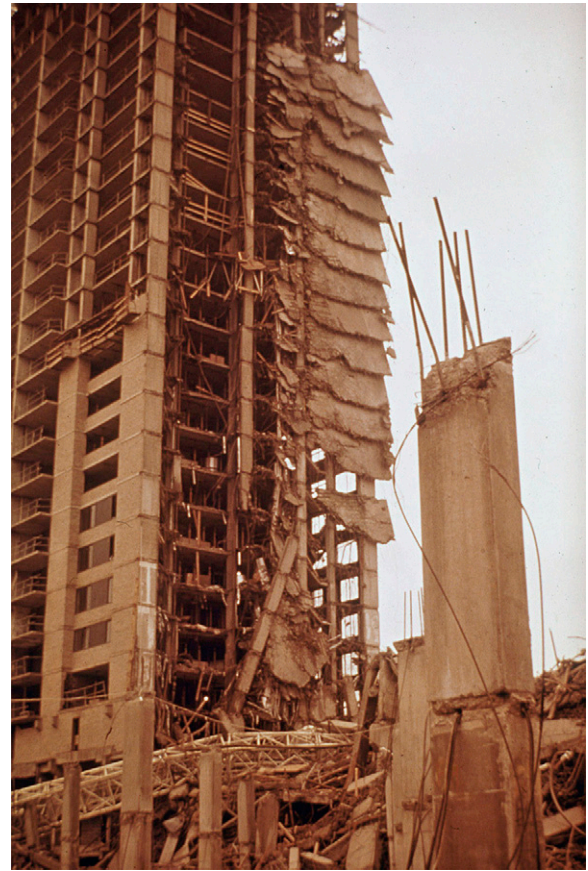
Fig. 4. Close-up view of the collapsed structure (courtesy of NIST)

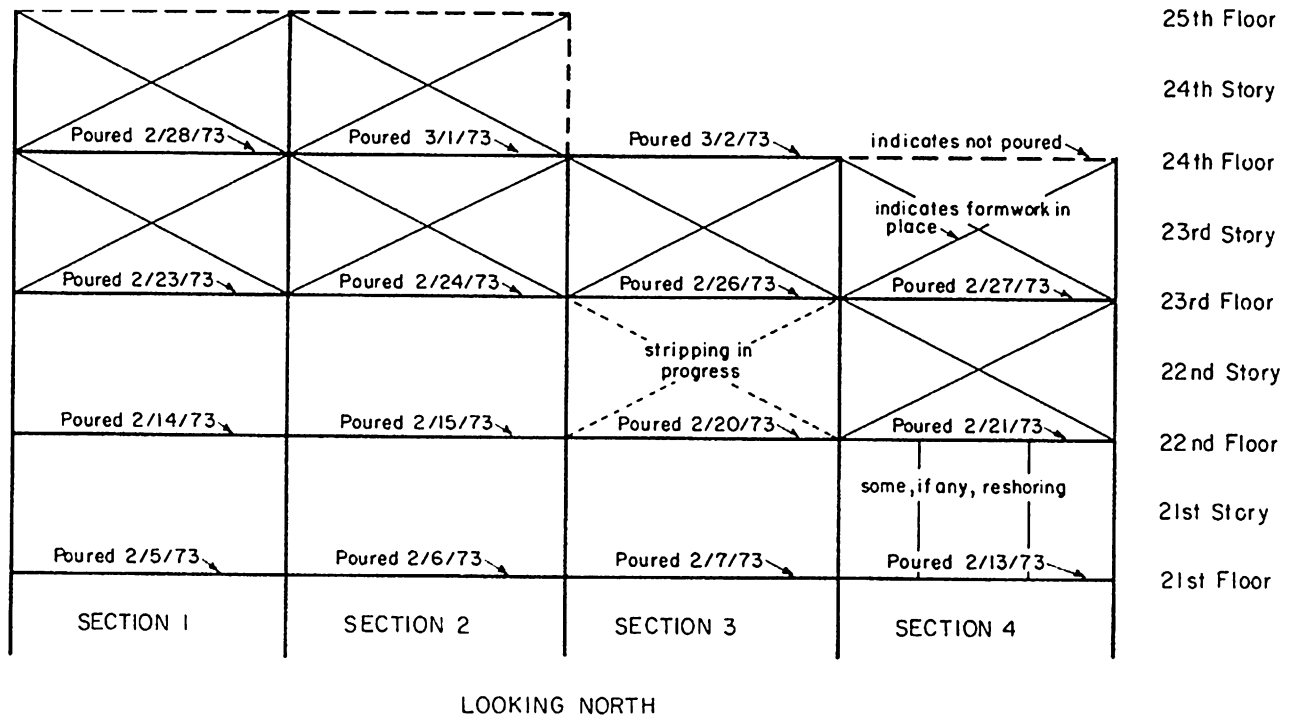
To determine whether premature removal of shoring or failure to install reshoring had caused the collapse, it was necessary to determine what formwork was in place at that time. This proved difficult. Between the March 2nd collapse and the arrival of the NBS team on site, additional reshoring was placed to stabilize some parts of the building. Some of the workers’ statements about the status of the shoring conflicted with each other. One worker who was installing reshores on the 21st floor claimed to have heard formwork and shoring removal on the 22nd floor at about 2 p.m. Careful analysis of photographs taken right after the collapse showed that while full shoring remained on the 23rd and 24th stories, it had nearly all been removed from the 22nd story in sections 1 and 2, but remained in section 4. The condition of the formwork in section 3 could not be observed because nearly all of this section had collapsed. The engineer’s structural drawings required 2 full stories of shoring and 1 story of reshoring while a concrete slab was being cast. The NBS team concluded that the estimated location of forms, shores, and reshores at the time of the collapse was as shown in Fig. 6, with all formwork removed on sections 1–3 of the 22nd floor and little if any reshoring on that floor (Leyendecker and Fattal 1977, pp. 18–31).

Some workers said that all of the shoring was removed on both floors, some said that only some was removed, and others believed that all was still in place at the time of collapse (Leyendecker and Fattal 1977, p. 18). However, the statements of one worker gave the investigators a good idea of the state of the forms at the time of the collapse. Leyendecker and Fattal (1977, p. 31) reported “One workman indicated that, at the time of the incident, he was placing reshores in section 3 of the 21st story and that some reshores were present when he started working. Prior to the incident, all the reshores fell out (except those in the balcony areas). This is consistent with what would be likely to occur if the forms had been removed in the story above.” If the shoring had been removed in the 22nd floor, the 22nd floor slab would have been relieved of its previous loads. With less loading, the deflection would have decreased in the slab, causing the reshores on the 21st floor to fall out.

Fig. 6. Estimated location of forms and reshores at the time of the collapse (Leyendecker and Fattal 1977, p. 30)

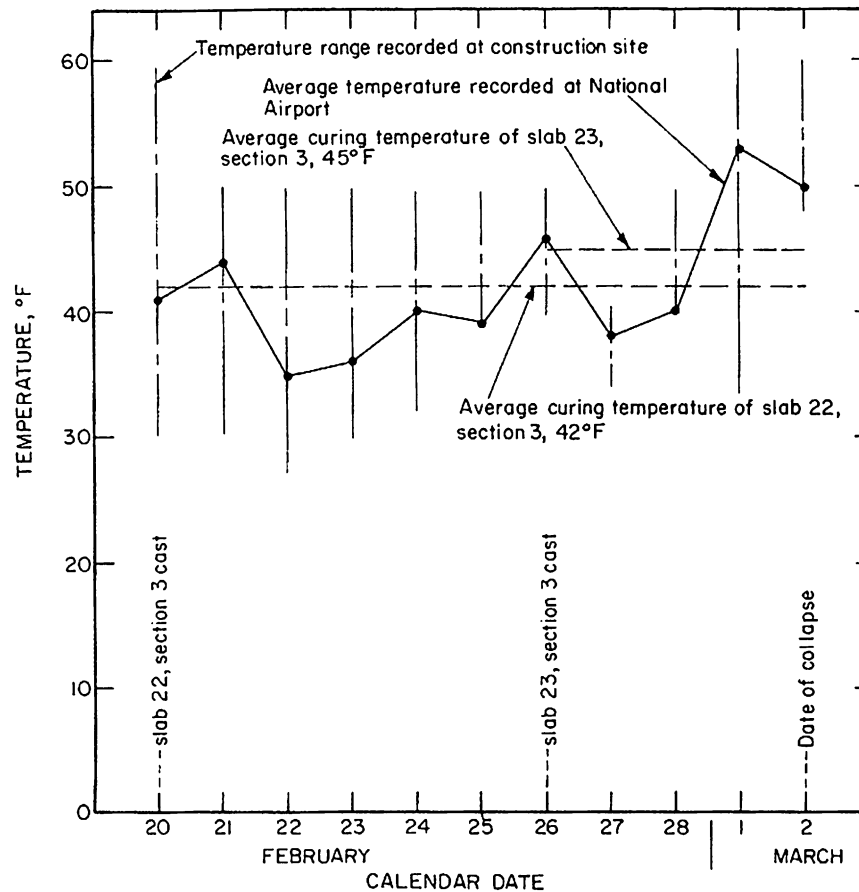
floor and 7°C for the 23rd floor (42 and 45°F , respectively) (Leyendecker and Fattal 1977, p. 60). The temperature history is shown in Fig. 7. Concrete cured at (5.6°C) (42°F) for 1 week would have a $\text{TTF} = (5.6 + 10) \times 7 = 109^\circ\text{C} - \text{days}$ [$(42 - 14) \times 7 = 196^\circ\text{F} - \text{days}$]. In contrast, concrete cured at the standard laboratory temperature of 23°C (73°F) would have a $\text{TTF} = (23 + 10) \times 7 = 231^\circ\text{C} - \text{days}$ [$(73 - 14) \times 7 = 392^\circ\text{F} - \text{days}$]. In other words, at 5.6°C (42°F), concrete takes about twice as long to gain strength as at standard laboratory temperature.

Fig. 7. Temperature history (scale $0^{\circ}\text{F} = -18^{\circ}\text{C}$ and $60^{\circ}\text{F} = 15.6^{\circ}\text{C}$) (Leyendecker and Fattal 1977, p. 63)
